**Township of Parsippany – Troy Hills
Evaluation of Water Service Failures in the
Glenmont Commons Development**

Final Report January, 2015

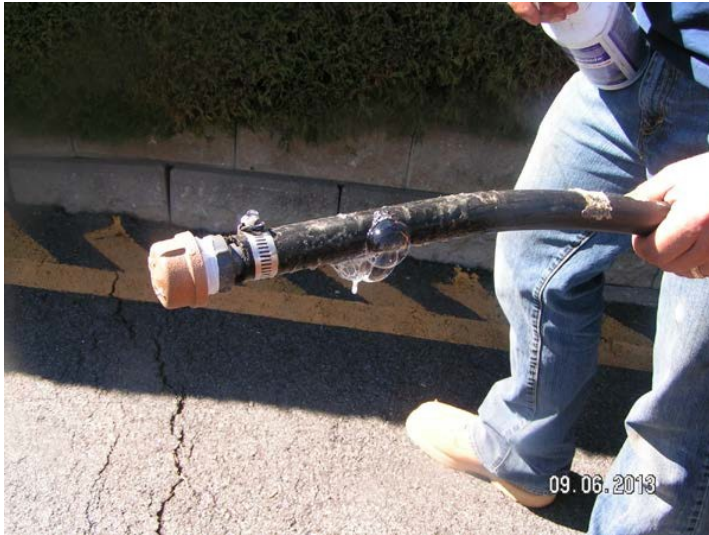
173 Springhill Drive: Small puncture in pipe determined when pipe was pressure tested.¹

The area of the leak was located 12 inches from the foundation. This area had significant settlement prior to the start of work. At no time did the leak make its way to the surface. It was noted that rocks where directly on top of the pipe at the point of failure. The pipe also was severely deflected either from settlement or from the backfill process at the point of failure. The failure was a small puncture created by the rock which was in contact with it. The Water Department has this section in their possession.

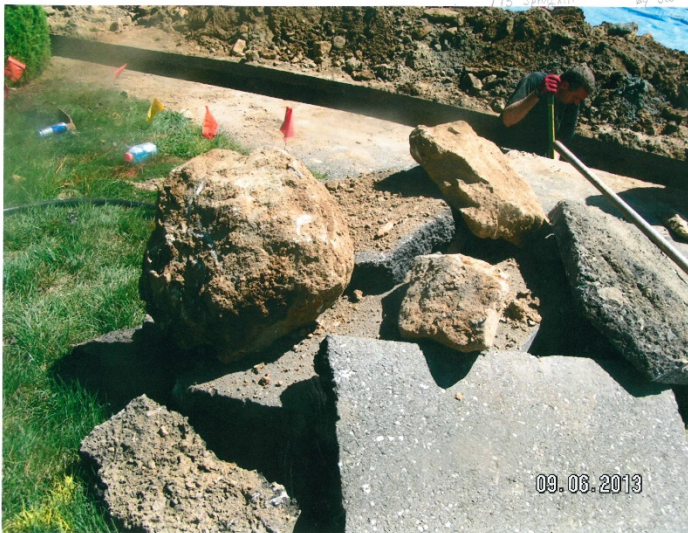
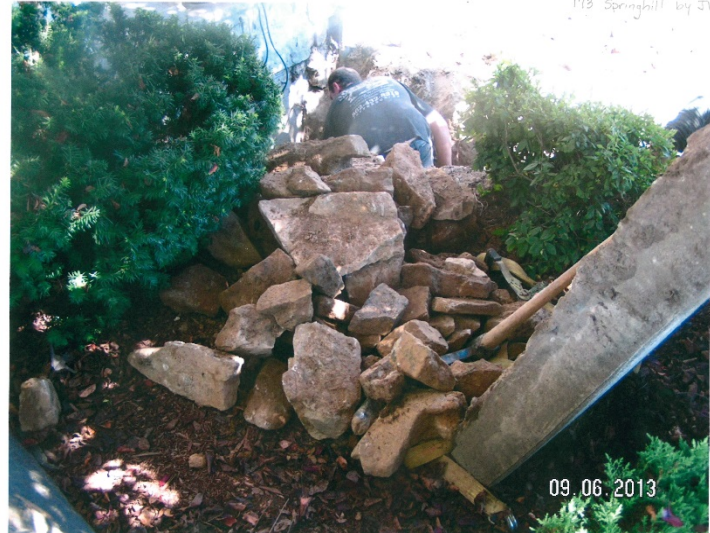
173 Springhill Drive: Pictures above show excavated material from line replacement.¹

During our observation it was noted that rocks of varying size where being removed from the excavation. These rocks were also present in the embedment zone of the pipe. The rocky fill was present throughout the excavation. We did not observe any select backfill on the private property. Just the mix of rocky fill that is native to the mountain.

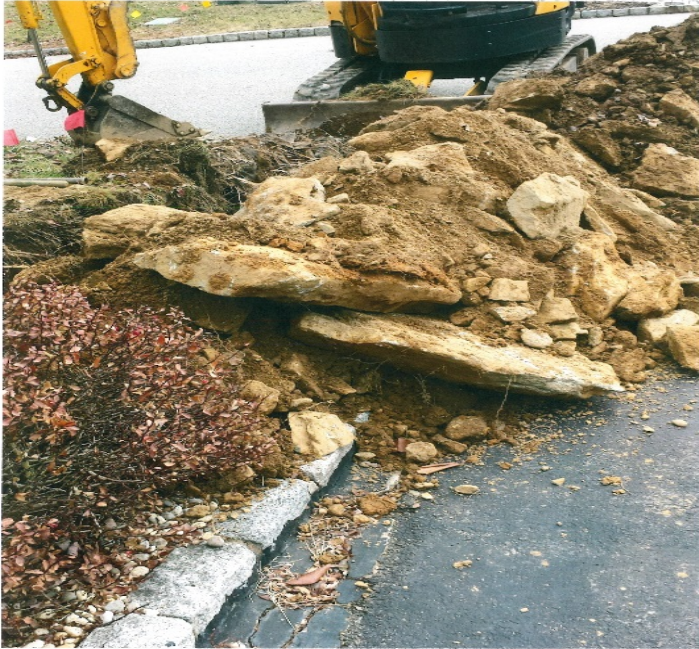
30 Seasons Glen: Existing service installation with no controlled back fill and large rocks against the service line.²

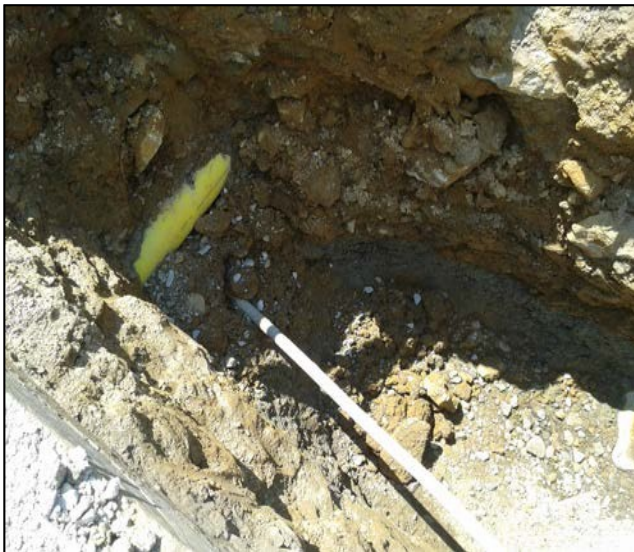
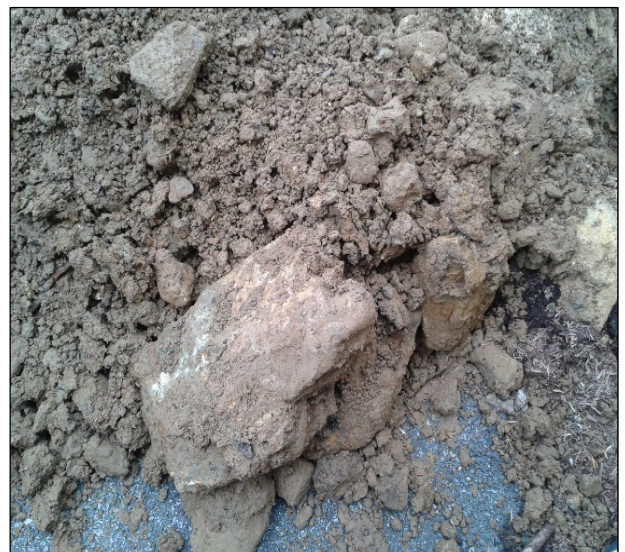
124 Springhill Road: Existing service installation with no controlled back fill and large rocks against the service line.³

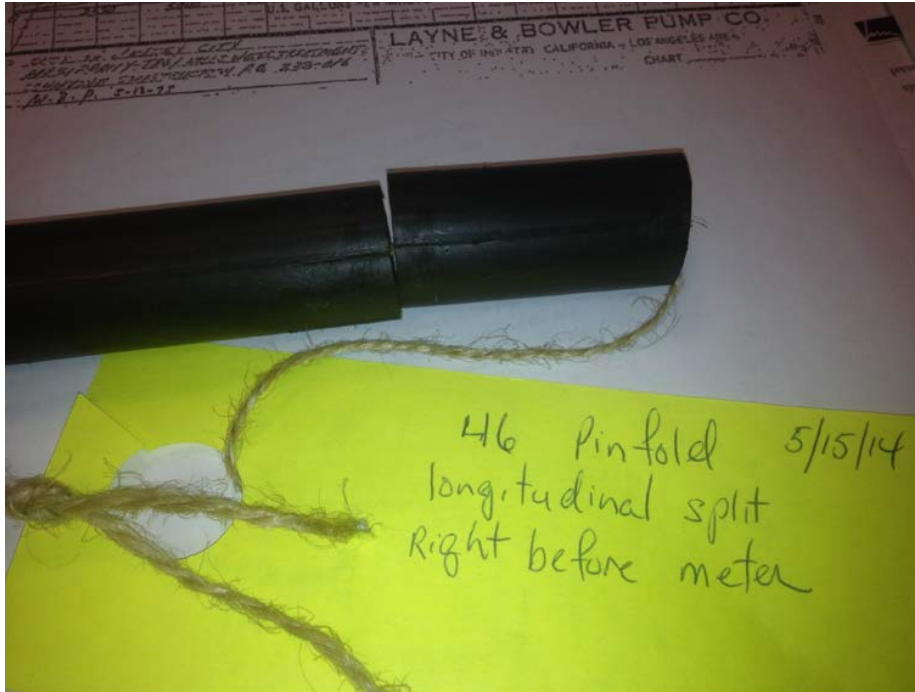
46 Pinfold Court: This pipe was cut in half after removal from inside wall of the residence. A longitudinal split can be seen on both sections of pipe. This sample was sent to Dr. Zhou, DOW Chemical for testing on July 22, 2014.⁴

On May 15, 2014, the Township obtained another sample pipe from the residence at 46 Pinfold Court. This pipe shows a longitudinal split as well as the pipe sample obtained from 11 Summer Hill Road obtained on September 19, 2014. The location of the failure was inside the residence at 46 Pinfold Court and therefore, not associated

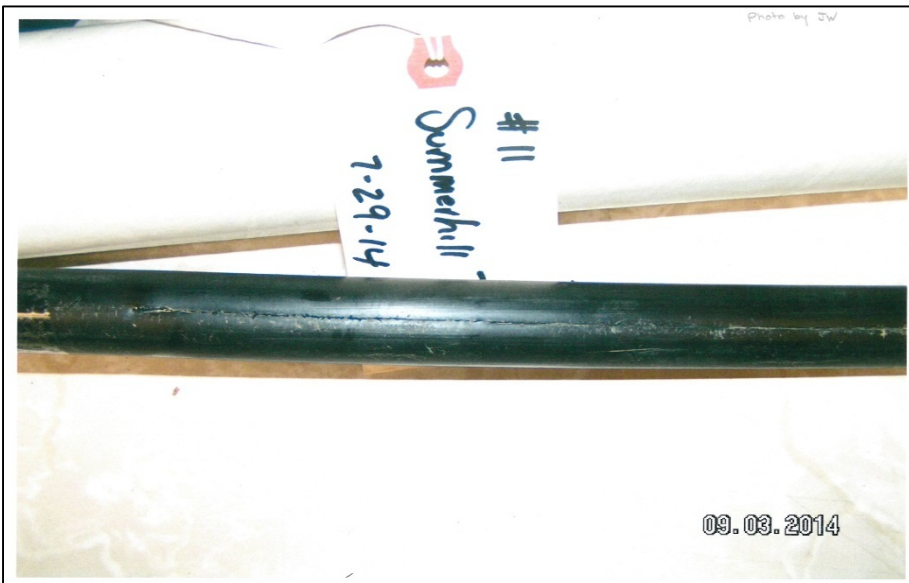
11 Summerhill Drive.: A longitudinal split can be seen. Received on 7/29/14. Sent to Dr. Zhou, DOW Chemical for testing on September 19, 2014.⁵

with any poor bedding installation outside and location of the failed pipe at 11 Spring Hill Drive was the underground service on the home owner's property leading to and underneath the porch.

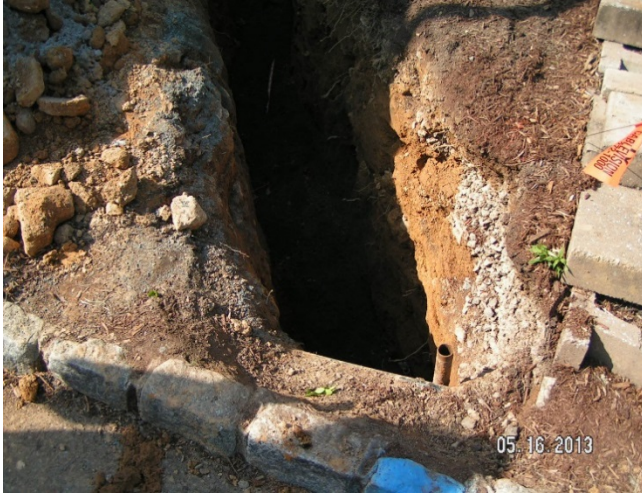
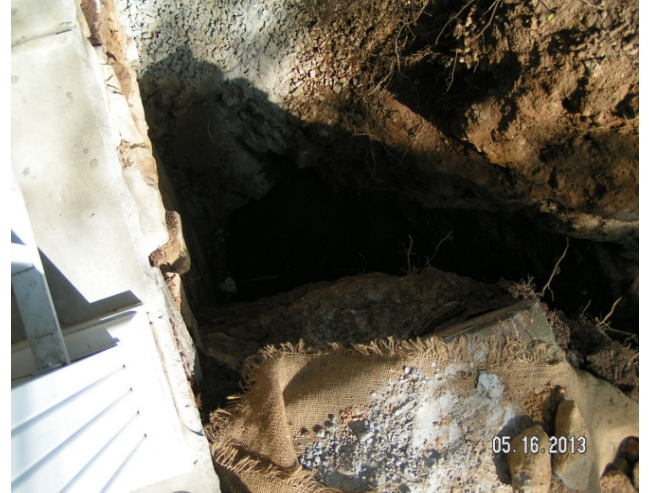
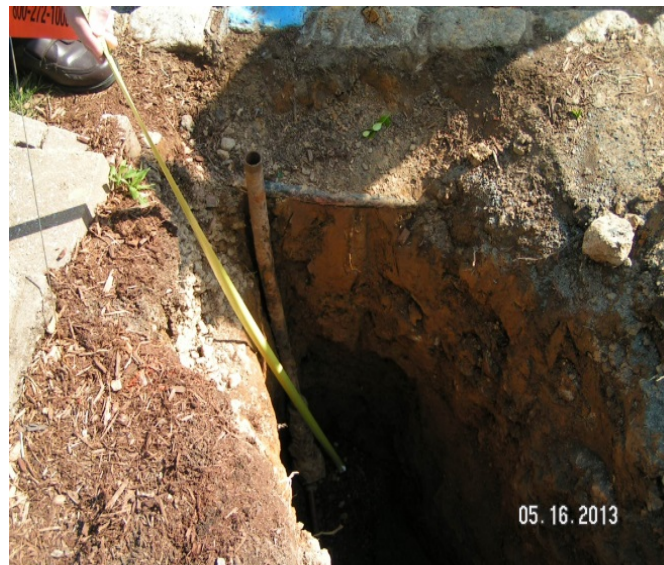
The Township also collected a sample of pipe from 17 Summerhill Dr. with a longitudinal split identified by Township personnel (no picture available of failed pipe; however, below are pictures of the trench that once housed it along with extracted backfill).⁶

- One sample of pipe (173 Springhill Drive) had a “ductile” failure when pressure tested to 850 psi and 900 psi. This is the normal anticipated failure mode for the pipe;
- One sample of pipe (17 Summerhill Drive) has a “non-ductile” failure when pressure tested to 550 psi and 600 psi. This failure is classified as “brittle” and is not the normal failure mode;
- Endot indicated that a test performed for depletion of anti-oxidant in the pipe, noted that the anti-oxidant package was somewhat depleted, but not enough to explain the brittle failure of the one piece of pipe;
- Endot requested additional information for the environmental factors associated with the pipe (i.e., water temperature, chlorine residual, internal pressure of the pipeline, pH of water)
- Endot indicated that additional testing will be performed by Dow on the pipe samples

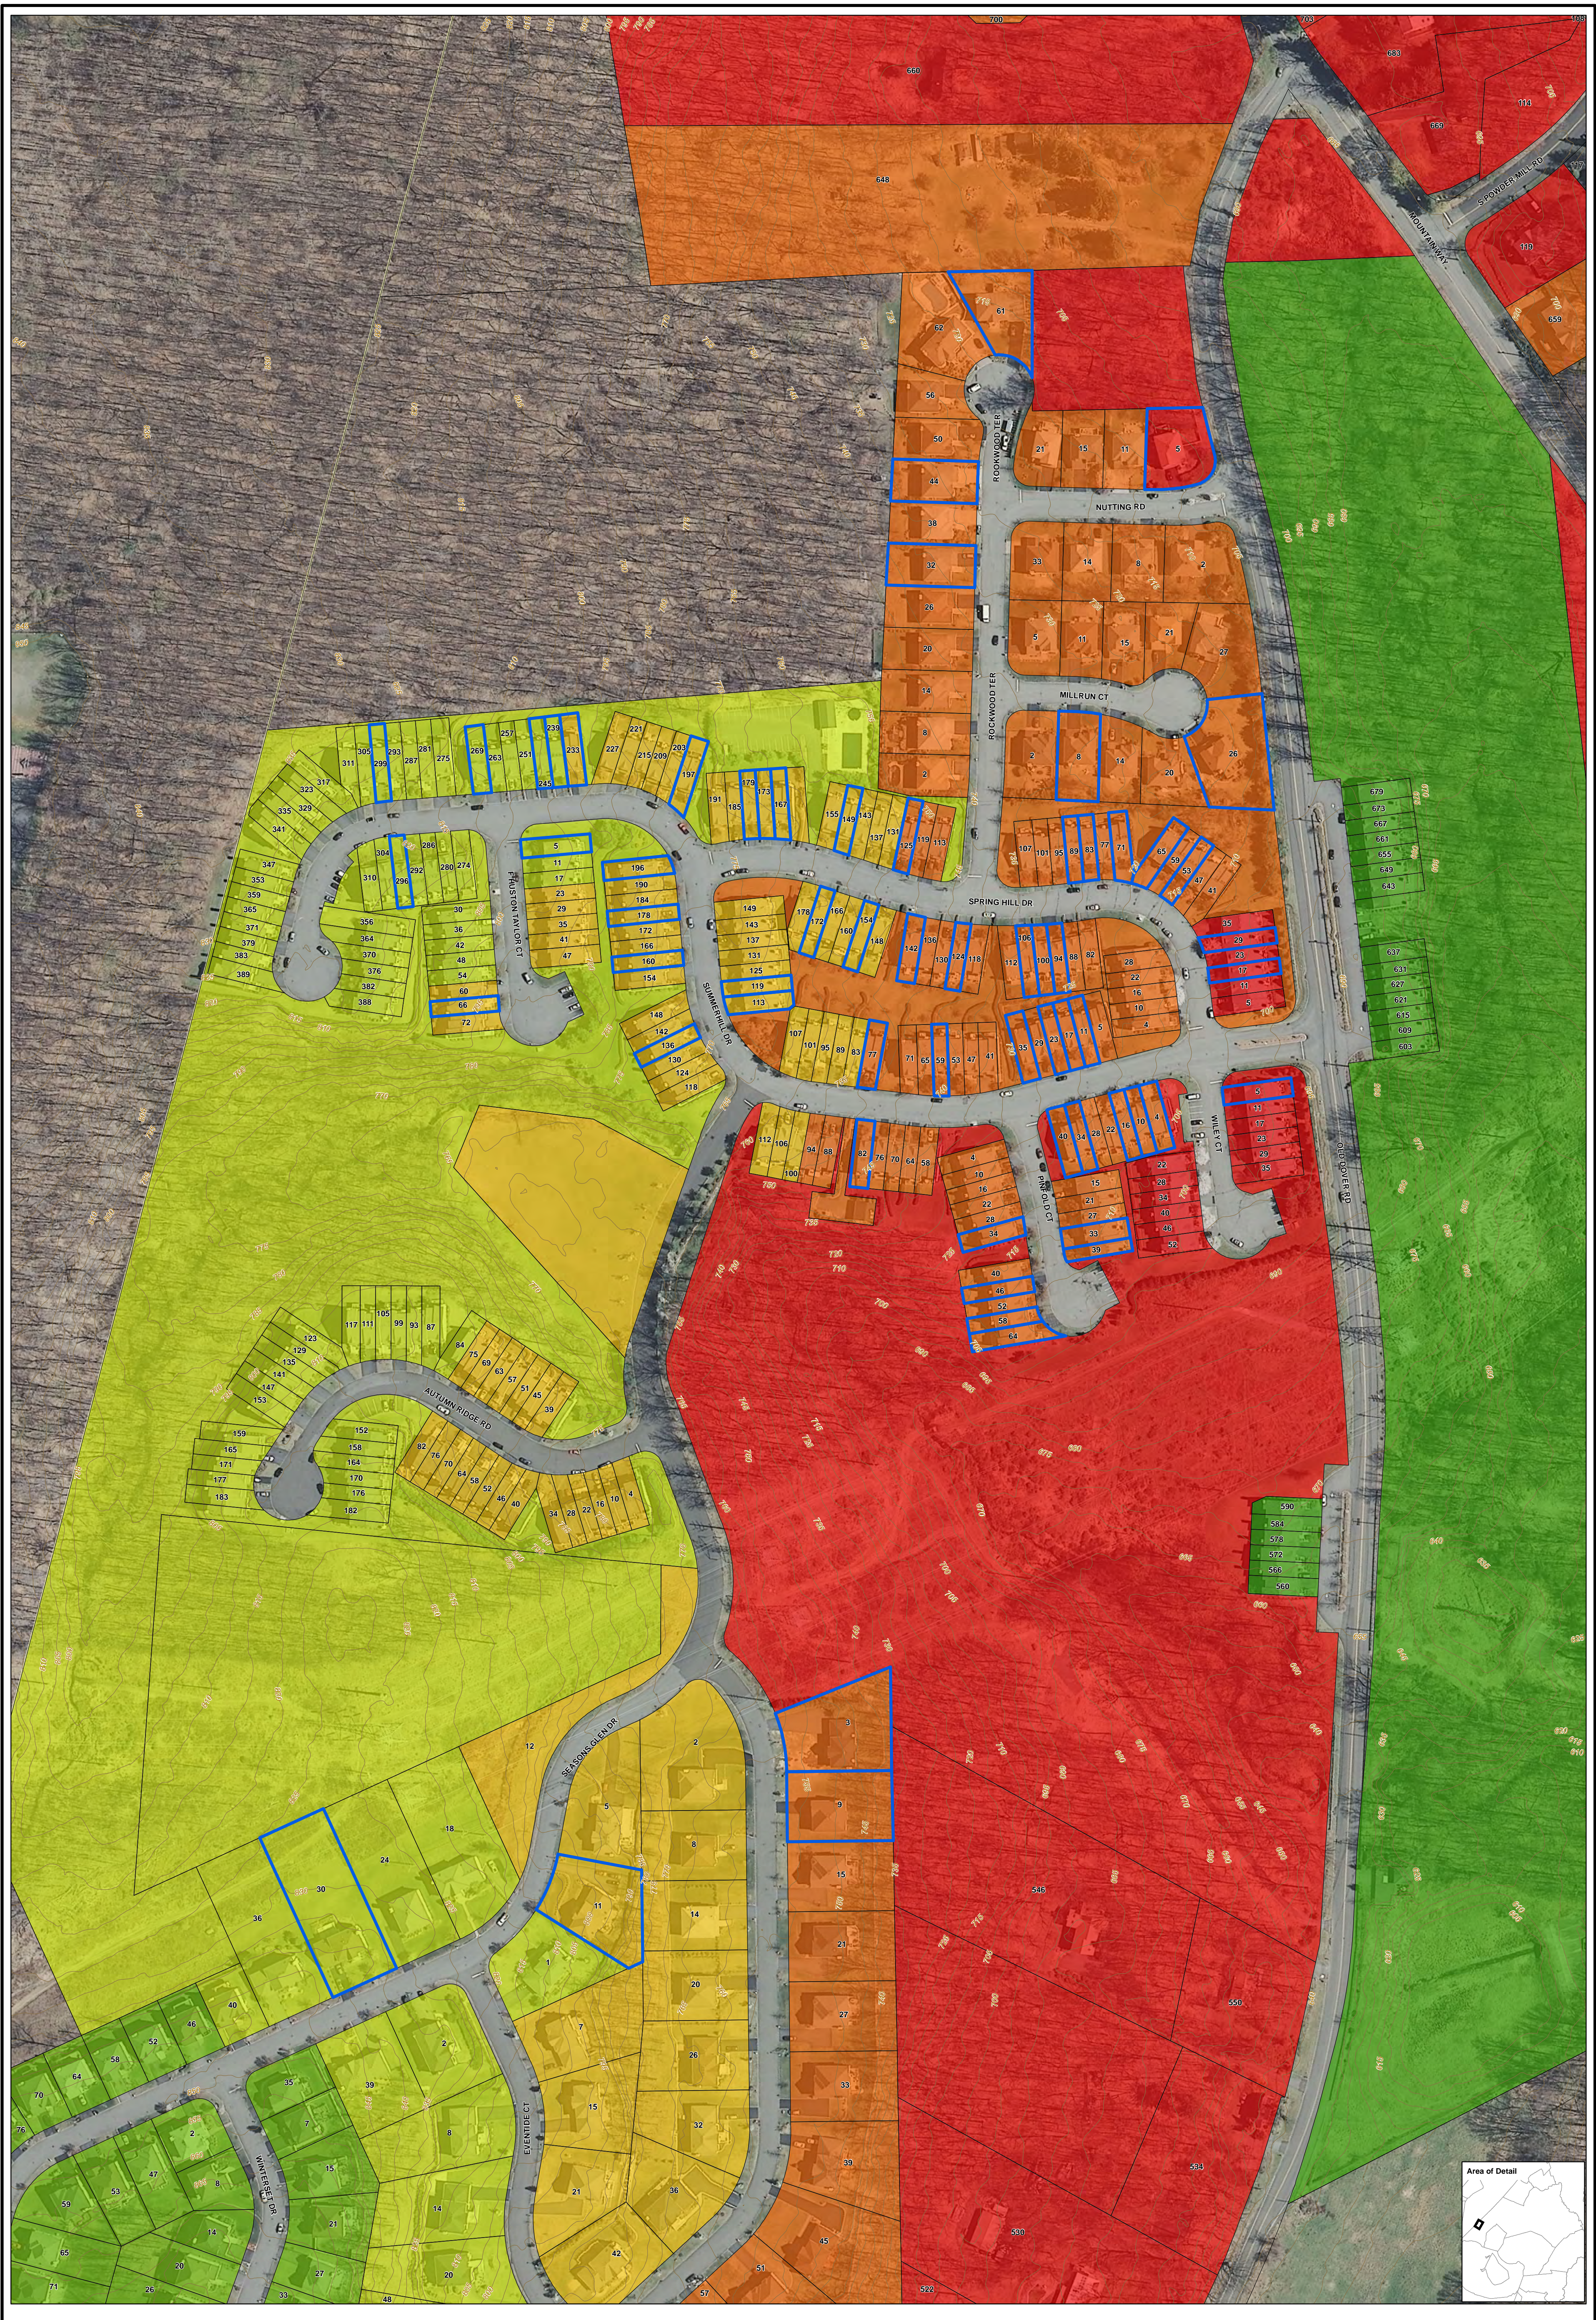
FAILURE LOCATIONS AND WATER SERVICE PRESSURES

The operating and delivery pressure to customers in the development range from approximately 90 to 200 pounds per square inch (psi). Refer to the attached map in **Appendix A** that shows the general pressure to customers and identifies those properties where service failures have occurred.

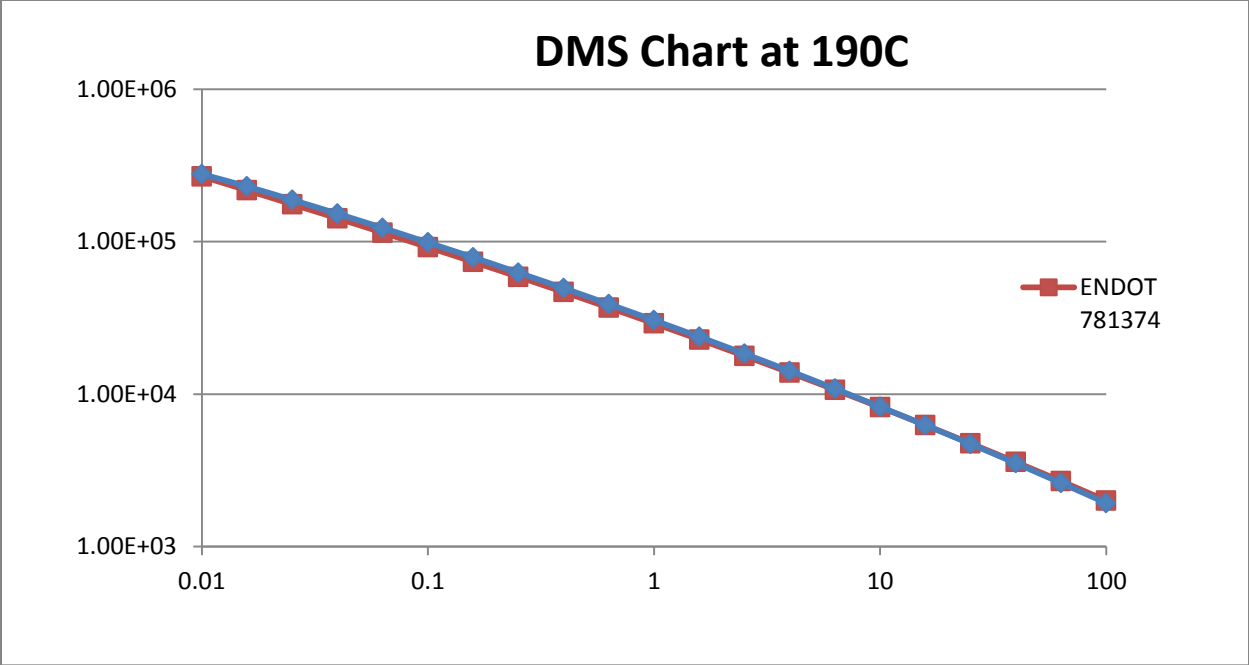
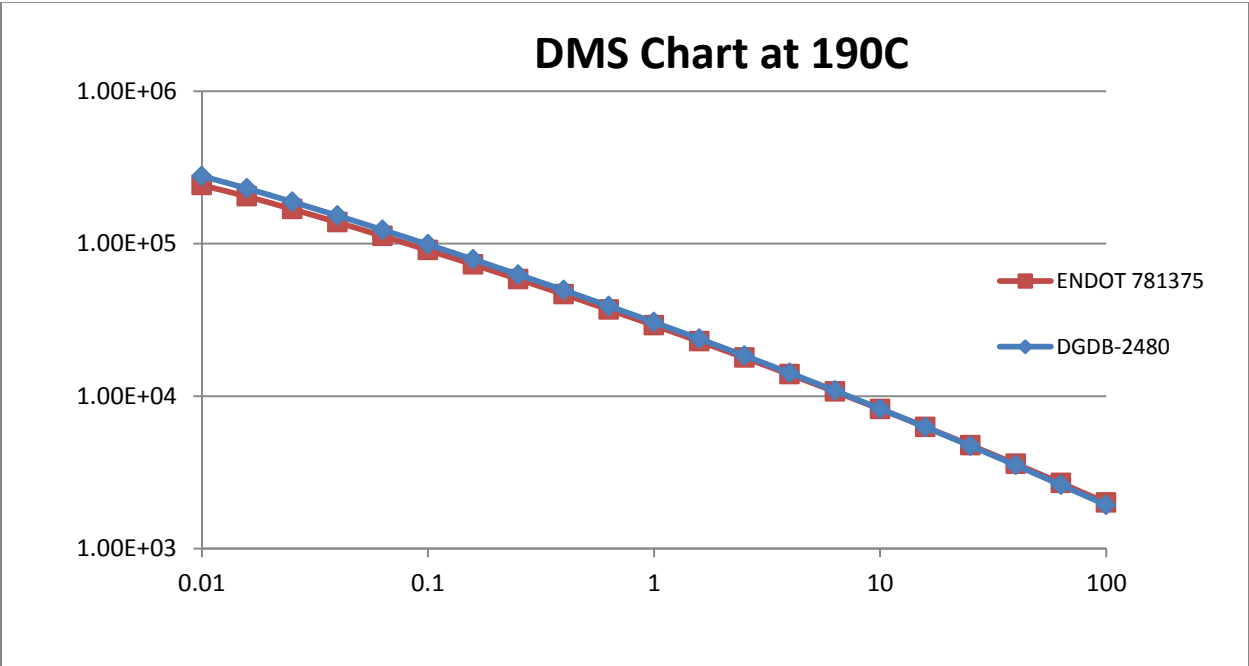
The following charts are the viscosity versus shear rates of the two samples at 190C. Since most likely DGDB-2480 resin was used to make the pipe samples, DMS chart measured from virgin DGDB-2480 resin was taken as a reference to compare with that measured on the two field pipe samples. 781374, the 1" black pipe with printline of November 1999 is identical to that of the virgin DGDB-2480. 781375, the 1" black pipe with red tape is almost completely overlapped with the exception of the lower viscosity curve at the low shear rates.

Sample 781374 seems to be identical to virgin DGDB-2480. No degradation was indicated. Samples 781375 displayed slightly lower viscosity at low shear rates. The viscosities at low shear rates are the responses of the high molecular weight part of the resin.
