**Township of Parsippany – Troy Hills
Evaluation of Water Service Failures in the
Glenmont Commons Development**

Final Report January, 2015

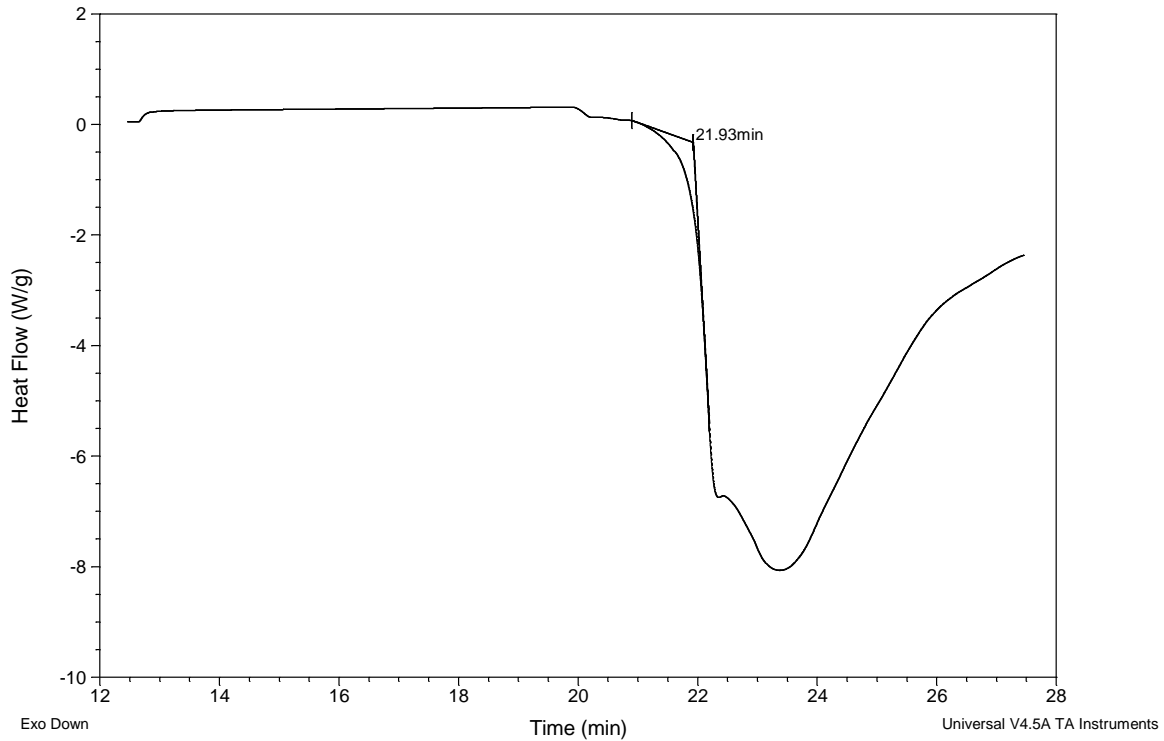
Sample 781374 seems to be identical to virgin DGDB-2480. No degradation was indicated. Samples 781375 displayed slightly lower viscosity at low shear rates. The viscosities at low shear rates are the responses of the high molecular weight part of the resin.

Based on the limited preliminary data, it is difficult to draw any conclusions. It is suggested to do further testing. In order to eliminating the sampling issue, it is further suggested to have the real failed pipe samples from the field. Testing directly on the failed samples will have better correlations between tested properties and the real field performance.
